DOT/FAA/AR-99/87

Vertical Drop Test of a Shorts 3-30 Airplane

November 1999

Final Report

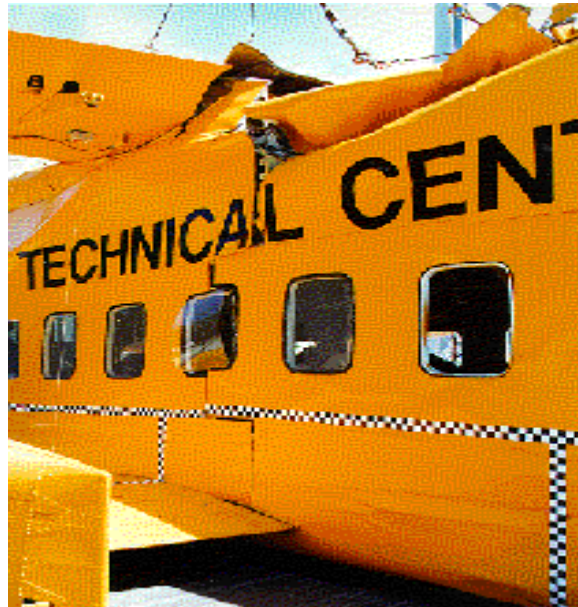
FIGURE 27. PILOT-SIDE FUSELAGE CRACK POSTTEST

Figures 23 – 30 show external damage to the fuselage, wings, and struts.

There were a number of large cracks in the fuselage skin after impact. The left side experienced a crack at FS 289 from the top of the fuselage down to the rivet line at WL 59. The crack then continued forward along the rivet line to FS 277. It then continued downward at FS 277 to the window and then on the bottom of the window down to the rivet line at WL 29. The crack then ran aft along the rivet line to FS 289. At FS 289 the crack continued downward to a point approximately 18 inches above the fuselage bottom at WL 18. The crack described above is shown schematically in figure 11.
